# Manhole Inspection Summary

Manhole # S21E1\_028MH

Insp Date: **5/22/08 3:01 PM**

**Location** Address: **2610 puget-huron alley**

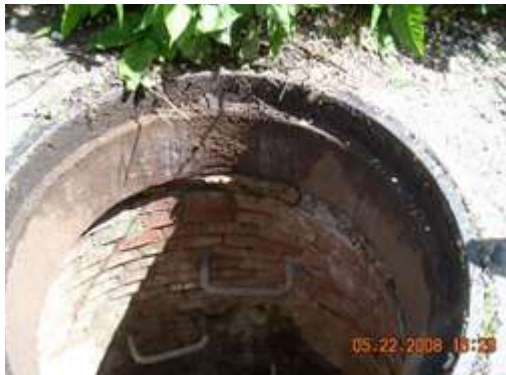
Defect 2

Subject To Ponding: **Sheeting**

inflow evidence from sheeting

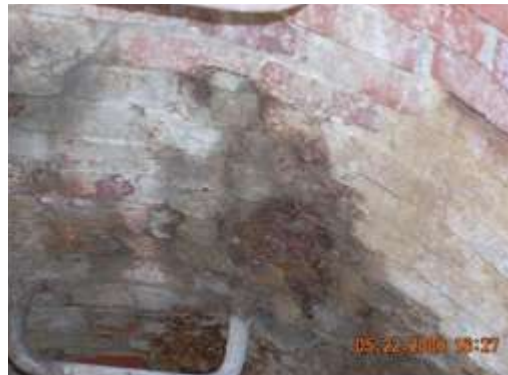
Defect 1

Infiltration: ☐ None ☐ Joint ☐ Cracks ☐ Mortar ☐ Roots ☒ **Wall**

infiltration @ barrel wall

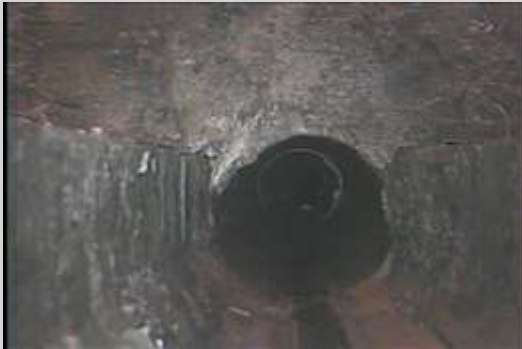
12 O'Clock Outflow

8 in. Circular Gravity Sewer  
Pipe Out @ 12 O'Clock

Pipe Height: **8.4** (in.) Rod and Bar (Angled)  
Pipe Material: **Clay** ☐ Pipe Lined  
Invert Depth: **7.26** (ft.) Flow Characteristics: **Slow**  
Deposits: ☐ None ☐ Mud ☐ Sludge ☐ Debris ☒ Grease  
Silt Depth: **1** (in.) Deposits Extent: **Light**  
Infiltration: **None** Pipe Seal Cond: **Unknown**

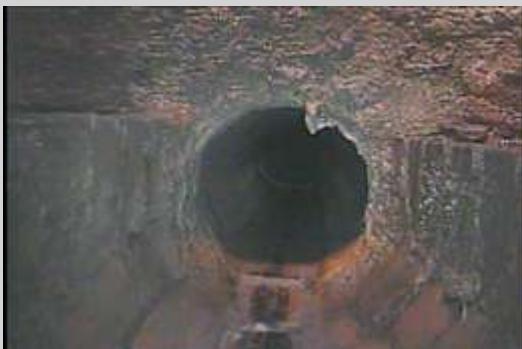
6 O'Clock Inflow

8 in. Circular Gravity Sewer  
Pipe In @ 6 O'Clock

Pipe Height: **8.4** (in.) Rod and Bar (Angled)  
Pipe Material: **Clay** ☐ Pipe Lined  
Invert Depth: **7.10** (ft.) Flow Characteristics: **Slow**  
Deposits: ☐ None ☐ Mud ☐ Sludge ☐ Debris ☒ Grease  
Silt Depth: **1** (in.) Deposits Extent: **Light**  
Infiltration: **Weeper** Pipe Seal Cond: **Unknown**

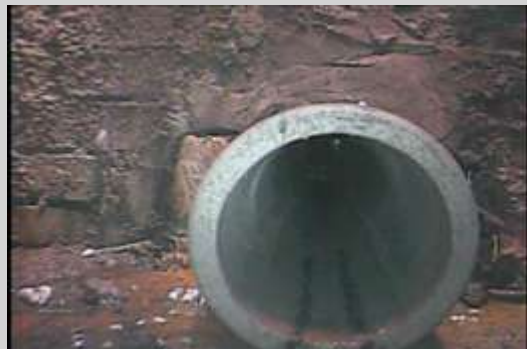
9 O'Clock Inflow

6 in. Circular Gravity Sewer  
Pipe In @ 9 O'Clock

Pipe Seal Cond: **Sound**
